**ASBESTOS SURVEY &  
LEAD-BASED PAINT  
INSPECTION REPORT**

**COMMERCIAL STRUCTURE  
735, 739 & 741 "H" STREET  
FRESNO, CALIFORNIA**

**May 28, 2014**

**SUBJECT: Asbestos Survey & Lead-Based Paint Inspection Report**  
Commercial Structure  
735 – 741 "H" Street  
Fresno, California

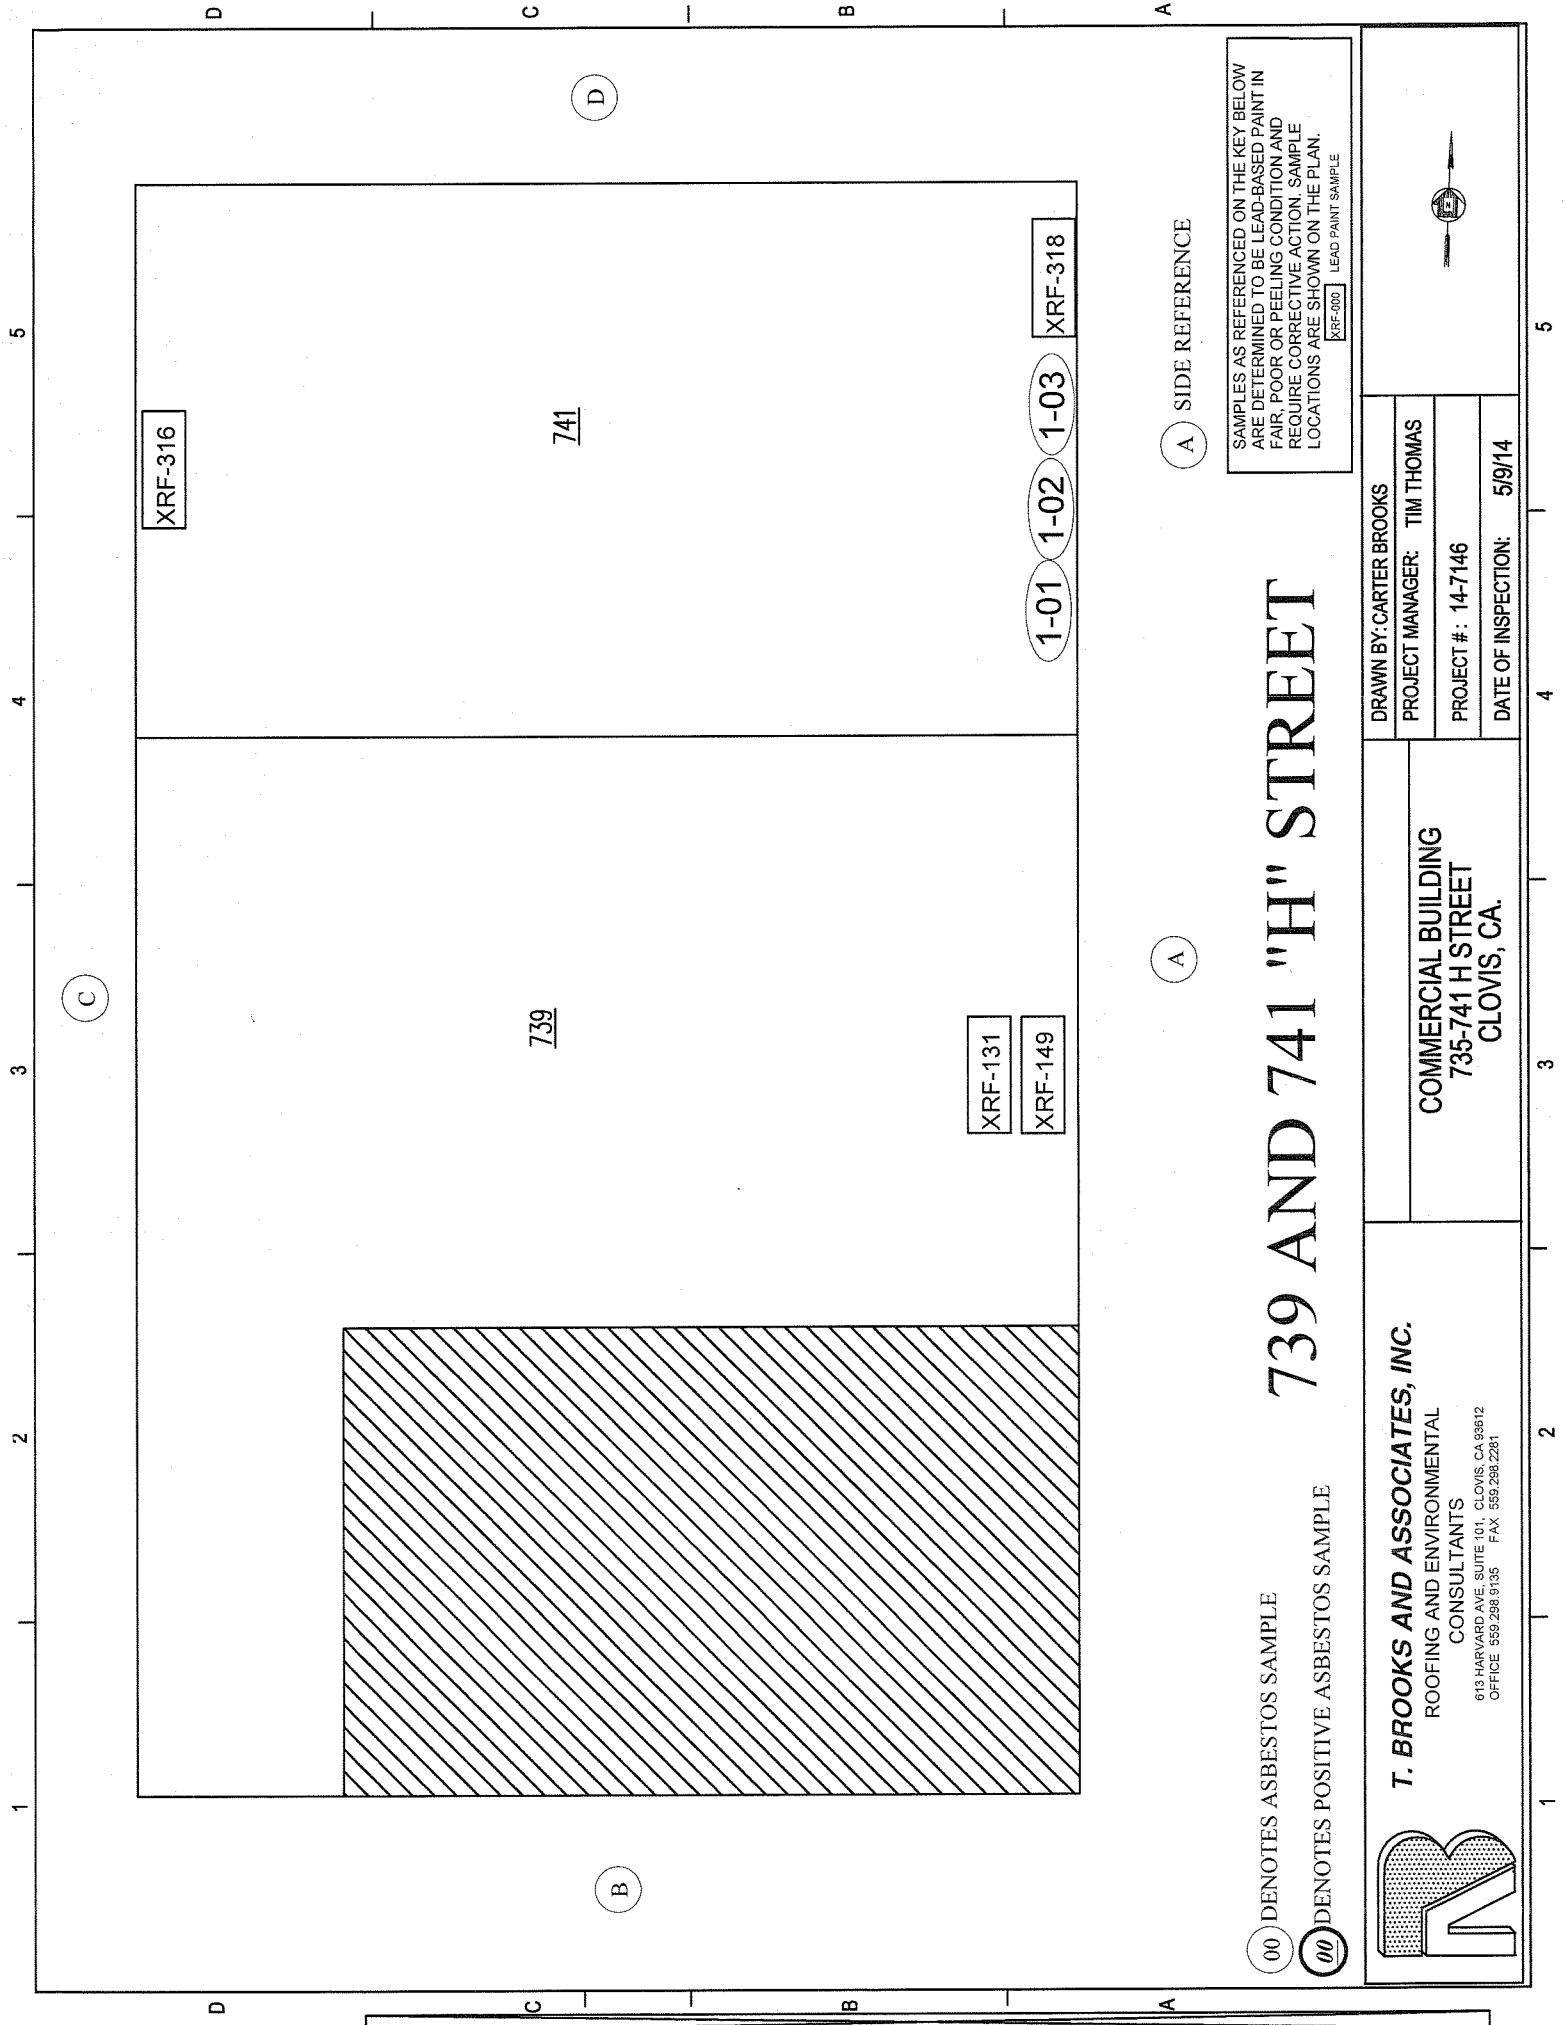
SAMPLES AS REFERENCED ON THE KEY BELOW  
ARE DETERMINED TO BE LEAD-BASED PAINT IN  
FAIR, POOR OR PEELING CONDITION AND  
REQUIRE CORRECTIVE ACTION. SAMPLE  
LOCATIONS ARE SHOWN ON THE PLAN.  
XRF-000 LEAD PAINT SAMPLE

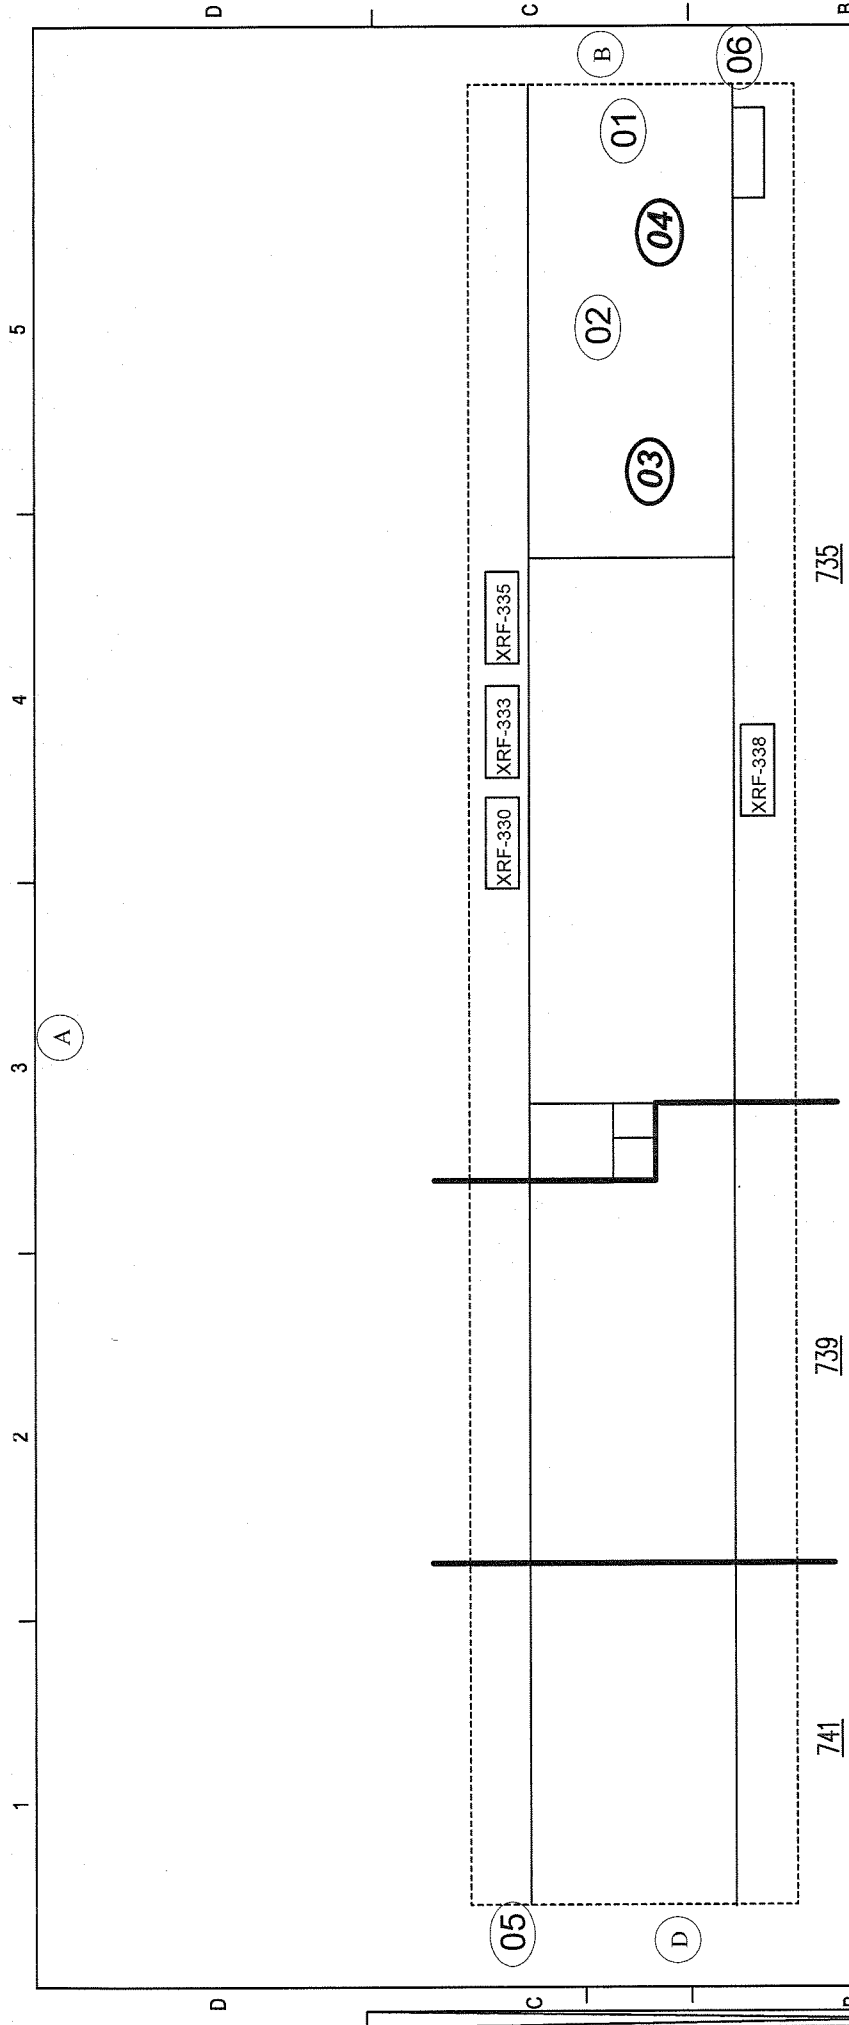
(A) SIDE REFERENCE

SAMPLES AS REFERENCED ON THE KEY BELOW ARE DETERMINED TO BE LEAD-BASED PAINT IN FAIR, POOR OR PEELING CONDITION AND REQUIRE CORRECTIVE ACTION. SAMPLE LOCATIONS ARE SHOWN ON THE PLAN.  
XRF-300 LEAD PAINT SAMPLE
