**LEAD-BASED PAINT SURVEY
BERKELEY BUILDING
877 FULTON MALL
FRESNO, CALIFORNIA**

Project No. 014-13105

June 6, 2013

Prepared by:
Krazan & Associates, Inc.
215 West Dakota Avenue
Clovis, California 93612
(559) 348-2200

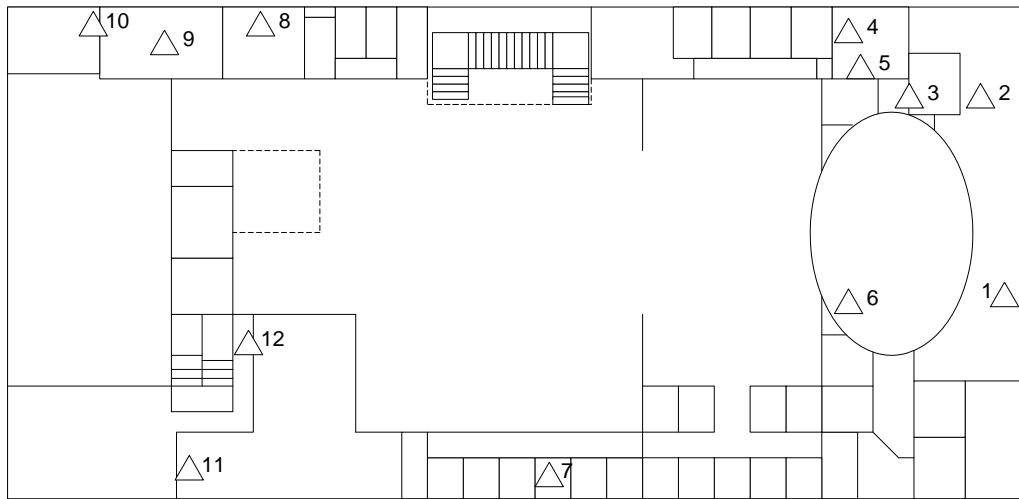
Second Floor

Pink gypsum board wall – 2nd floor (Sample No. 4)

Pink wood trim – 2nd floor (Sample No. 5)

Off-white gypsum board wall – 2nd floor (Sample No. 11)

Tan wood door frame – 2nd floor (Sample No. 3)

Red brick wall – 2nd floor (Sample No. 8)

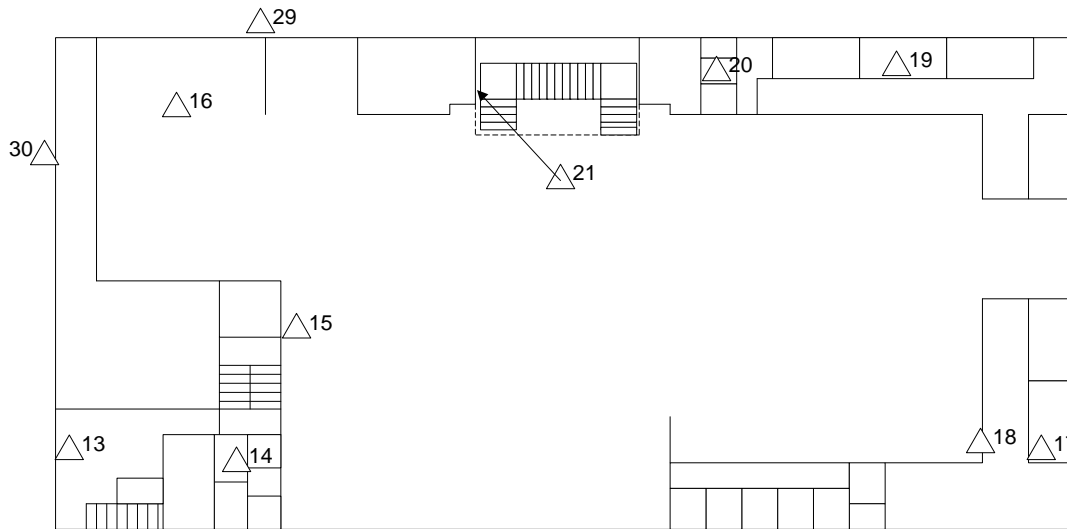
First Floor

Pink wood partition wall – 1st floor (Sample No. 20)

Off-white gypsum board wall – 1st floor (Sample No. 15)

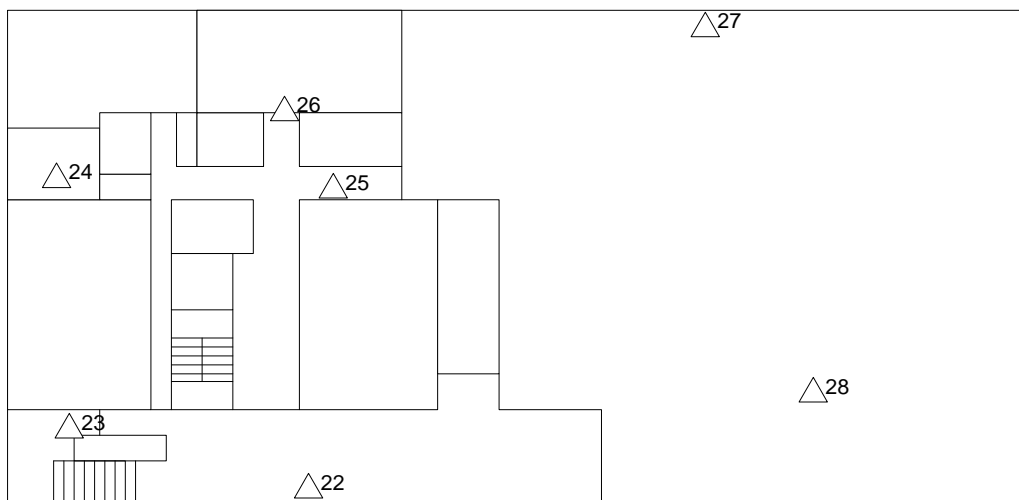
Basement Level

Tan plaster wall – basement (Sample No. 23)

Off-white plaster wall – basement (Sample No. 24)

Tan wood door frame – basement (Sample No. 26)
