**T. BROOKS &  
ASSOCIATES**

**LIMITED ROOF  
SYSTEM EVALUATION  
COMMERCIAL PROPERTY  
887 FULTON MALL  
FRESNO, CALIFORNIA**

**June 11, 2013**

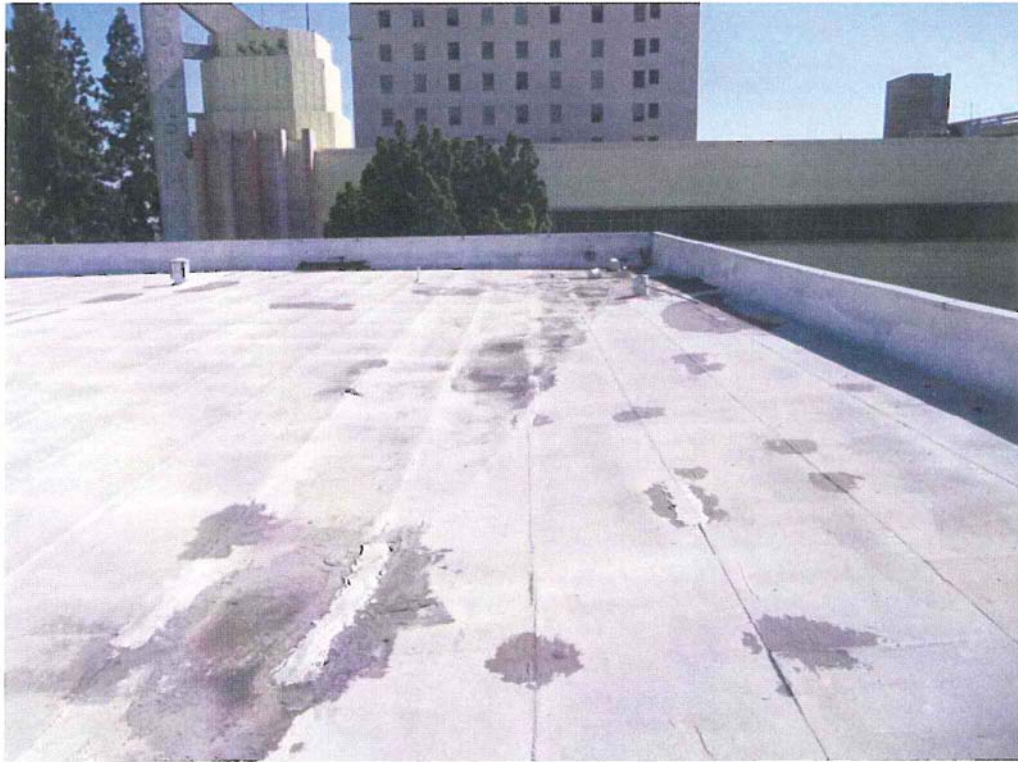
8. Elongated splits are present throughout the roof area, certain of which have been repaired. Many of these splits are currently not in watertight condition.

Photograph Number 1  
View of Large Cricket and Split Repairs

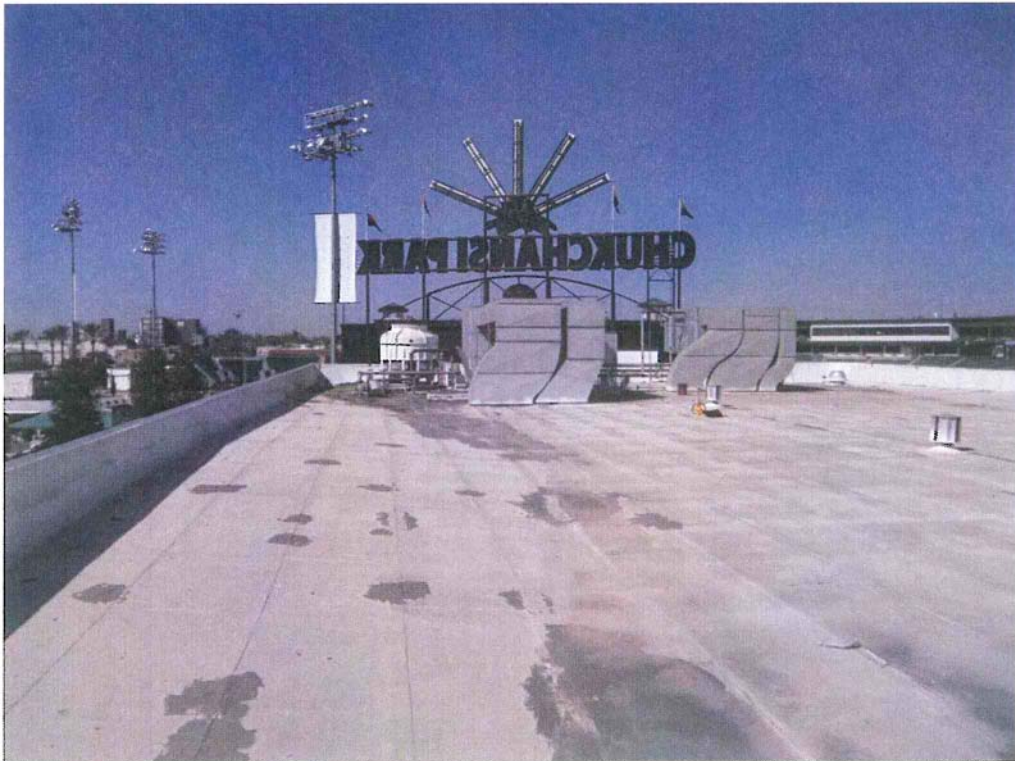
Photograph Number 2  
View of Mechanical Equipment at West End of Roof

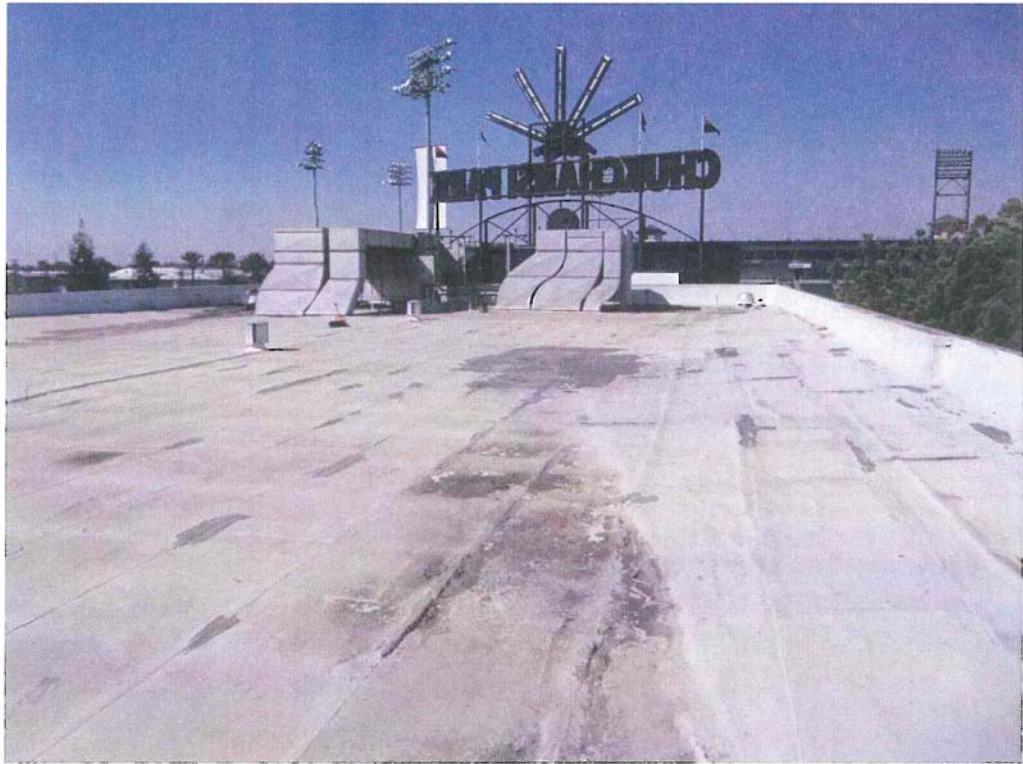
Drainage is provided by four (4) cast-iron drains located at each corner of the building. The structure includes thru-wall overflow drains as required by current building code. Large wood-frame crickets are located on each side of the roof and extend the length of the building between drains. Flow of water along the crickets is impeded by roof related elements resulting in ponding water

1. The current built-up roof system was found to be in poor condition.
2. Drainage was observed to be inadequate due to obstruction of the drainage plane by roof related elements.

Photograph Number 3  
View of Ponding Areas and Field Repairs

Redesign drainage system to provide proper drainage

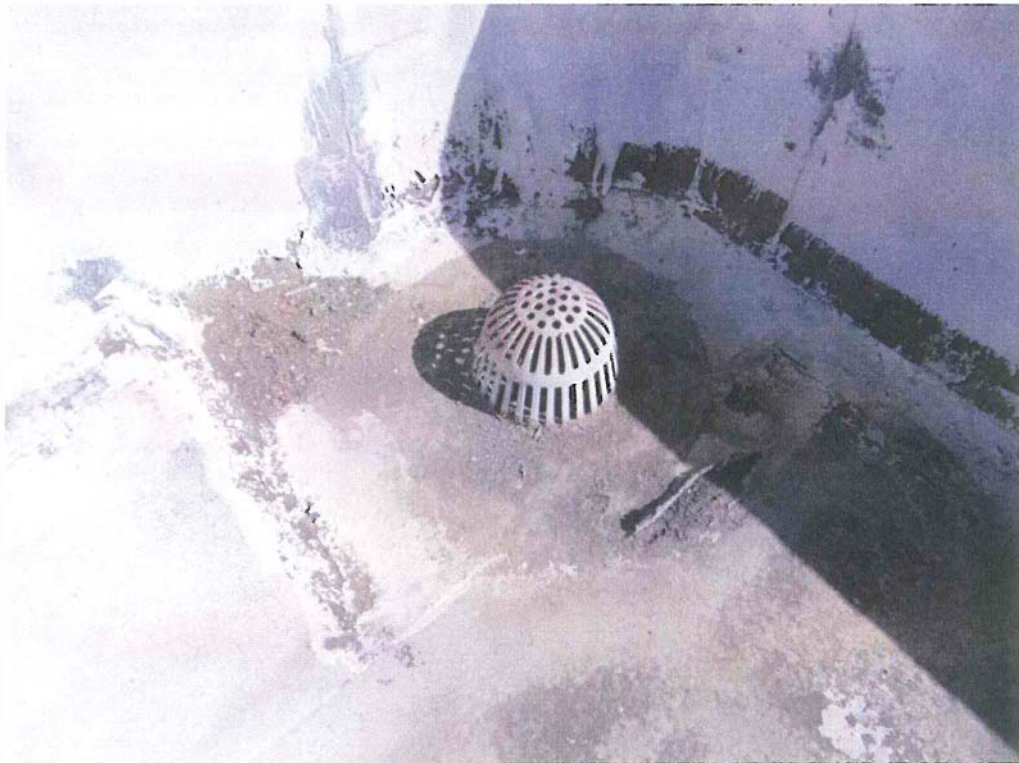
Photograph Number 4  
Typical Roof Drain

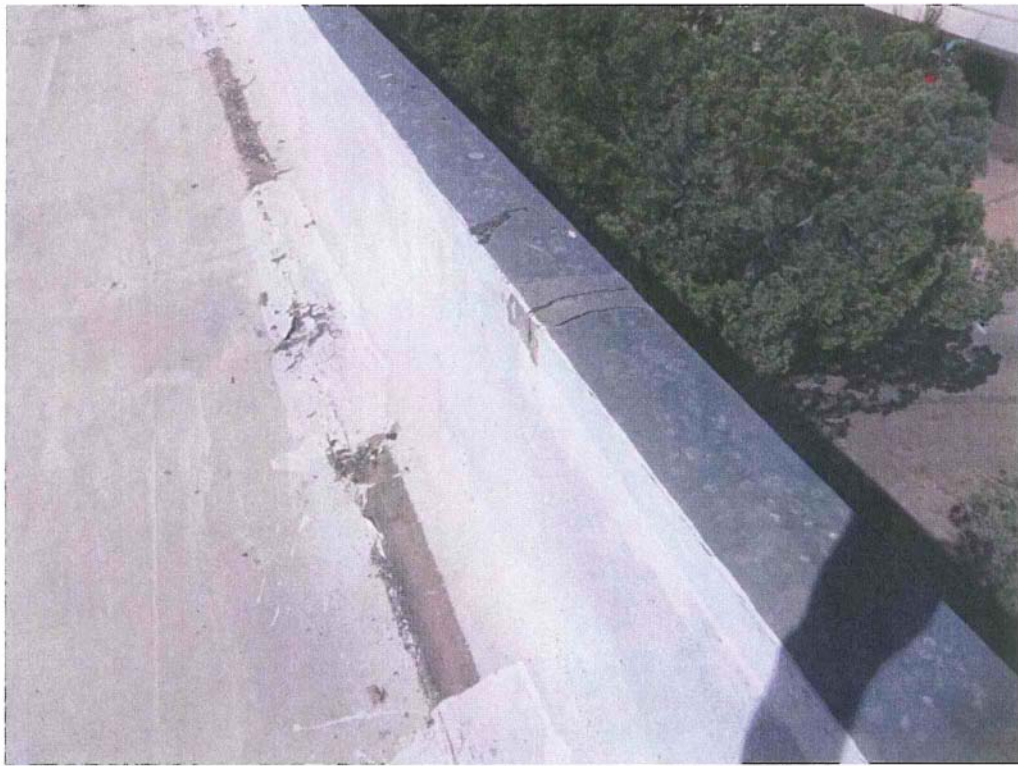
7. Sealant on joints of sheet metal cap flashings on top of parapet walls has failed. Existing joint type is unreliable and represents an ongoing maintenance item.

Photograph Number 5  
Failed Coping Joint and Repair at Base of Wall

Modify parapet coping joints to standing seam or drive joints to provide long-term, watertight condition and eliminate maintenance required by current joint configuration.

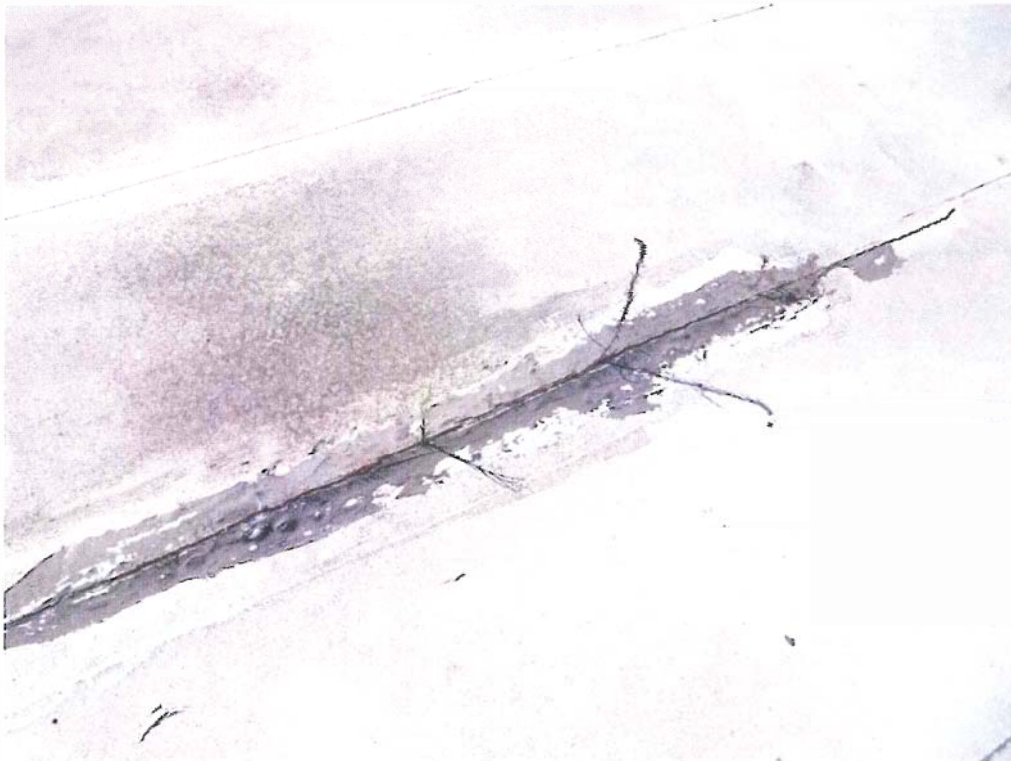
Photograph Number 6  
Failed Split Repair in Field of Roof

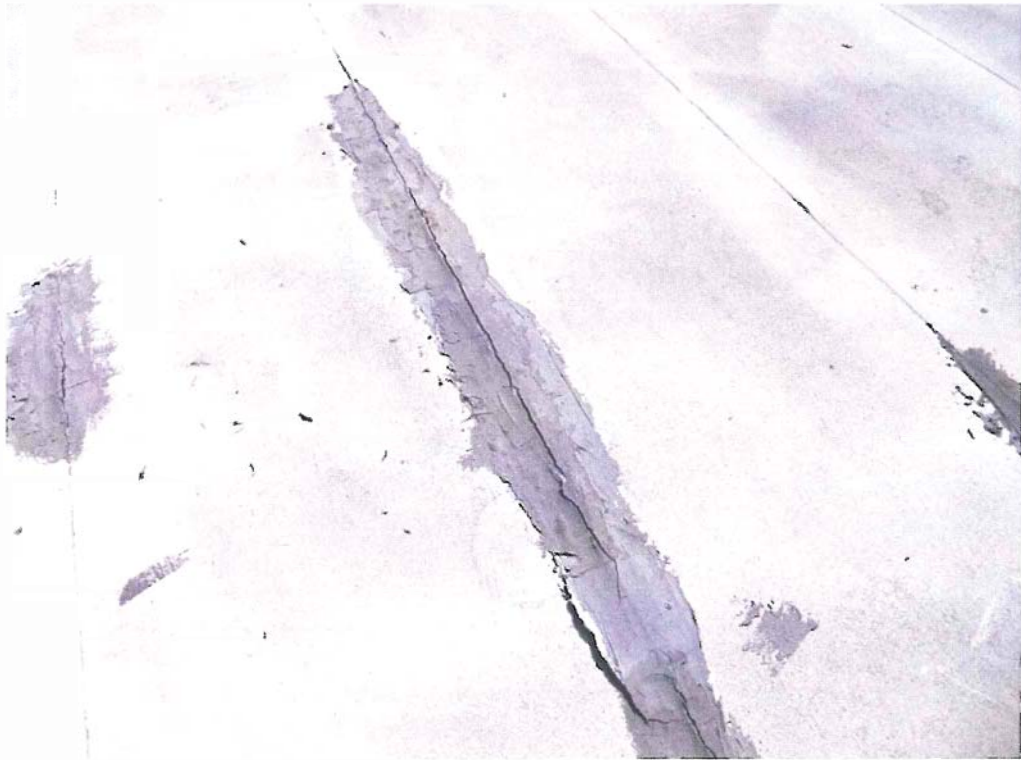
Photograph Number 7  
Failed Split Repair

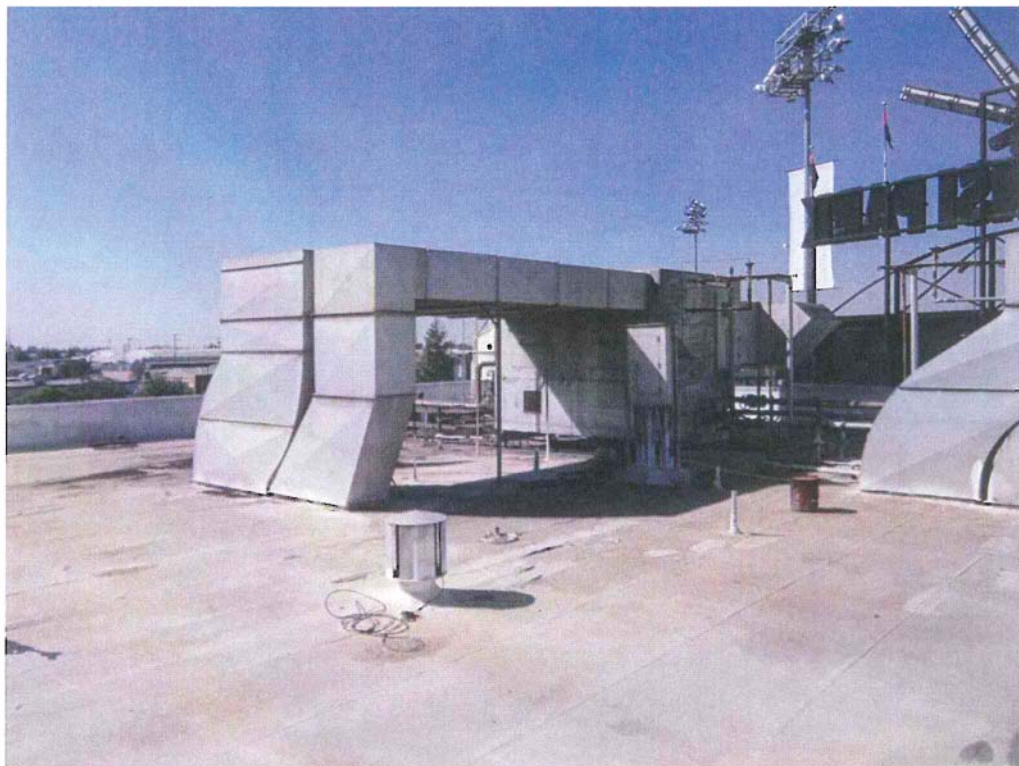
Photograph Number 8  
Mechanical Equipment Area

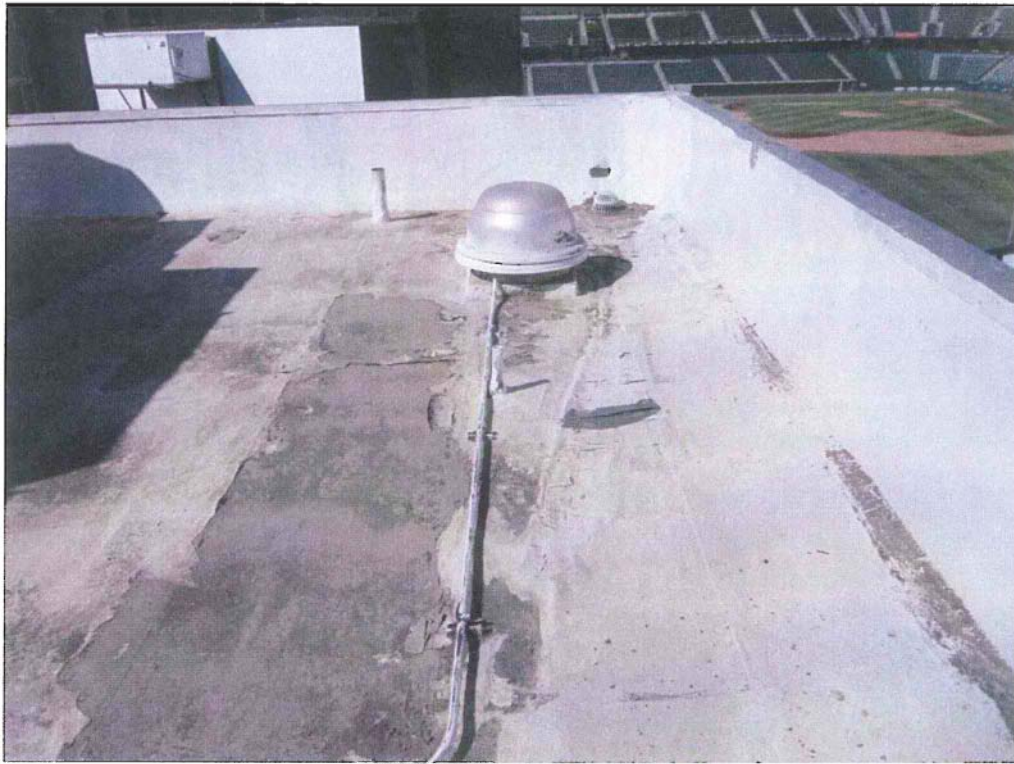
Photograph Number 9  
Vent at Corner of Roof Obstructing Drainage

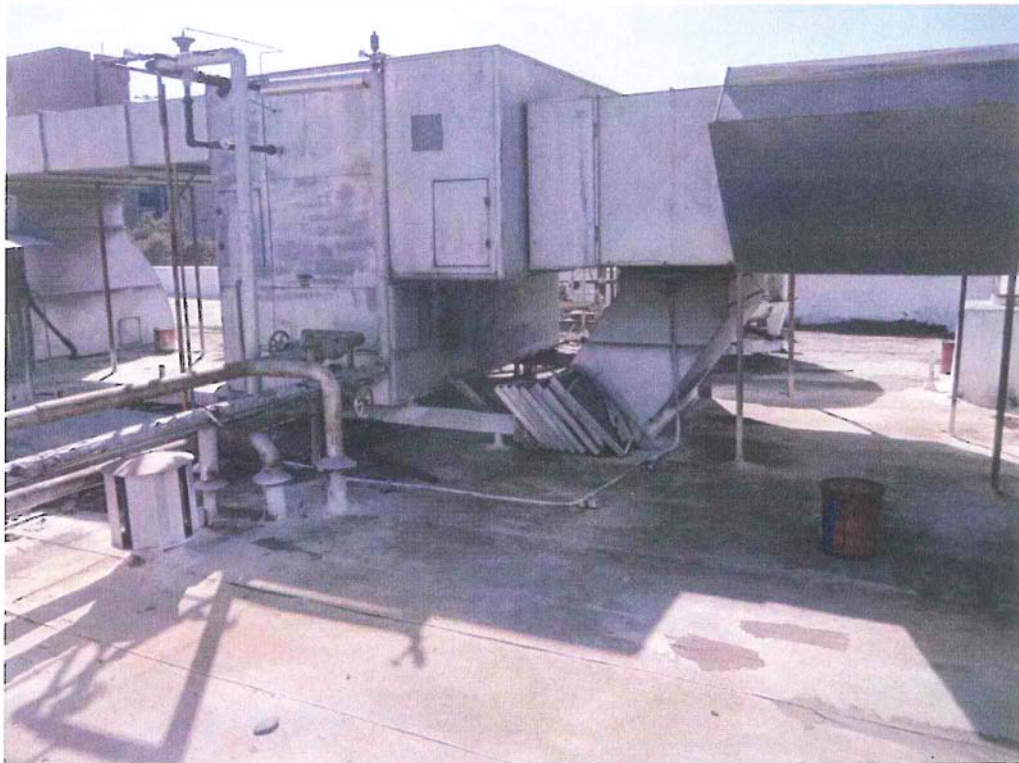
Photograph Number 10  
Large Air Handling Unit

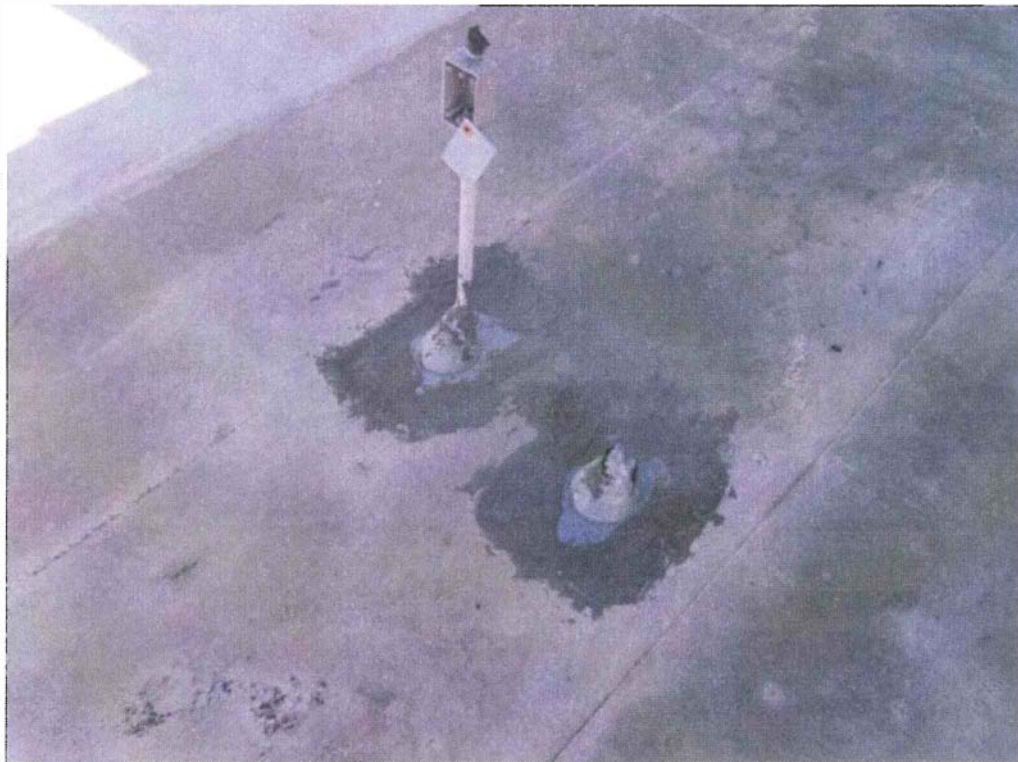
9. Certain flashing elements have not been properly incorporated into the roofing system.

Photograph Number 11  
Penetration Flashing Not Incorporated into Roof System

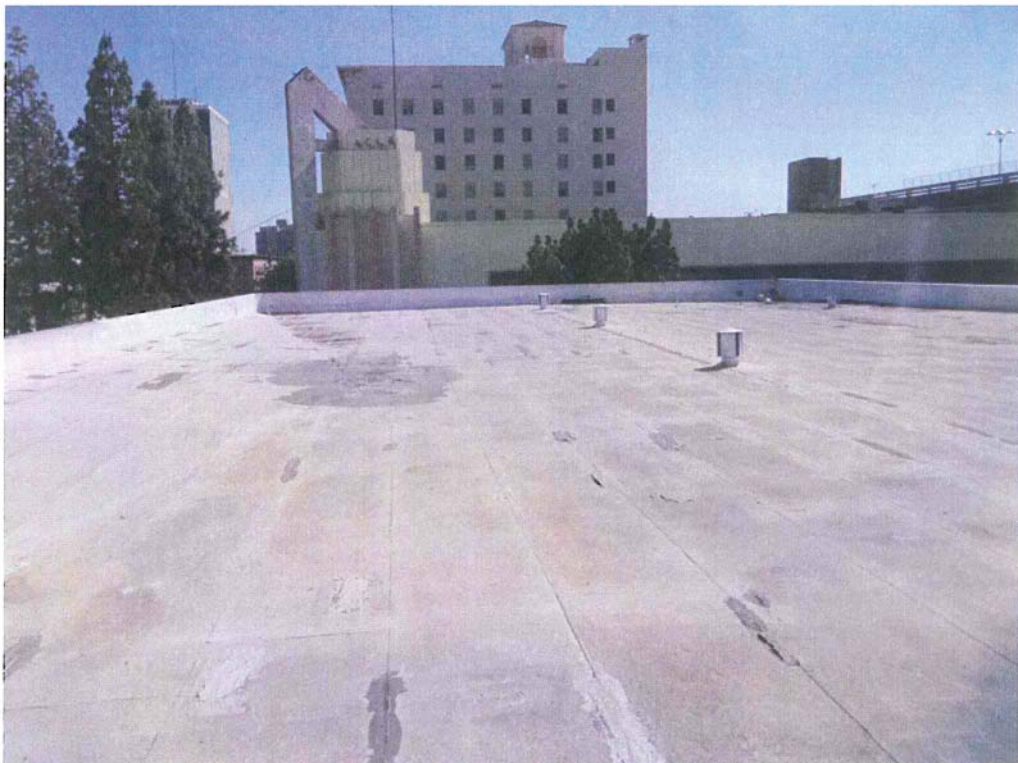
Photograph Number 12  
General View of Roof Area

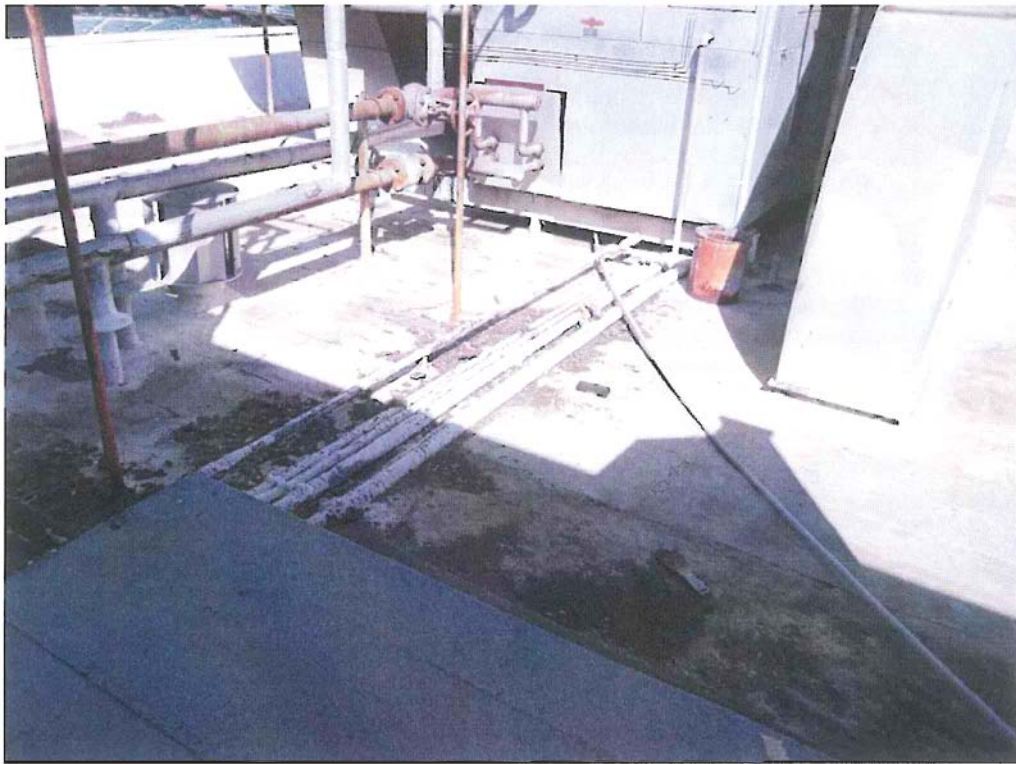
6. Roof-mounted electrical conduits are not properly supported above the roof per industry standards. Current condition may result in an electrical outage.

Photograph Number 13  
Electrical Conduits Not Properly Supported Above Roof

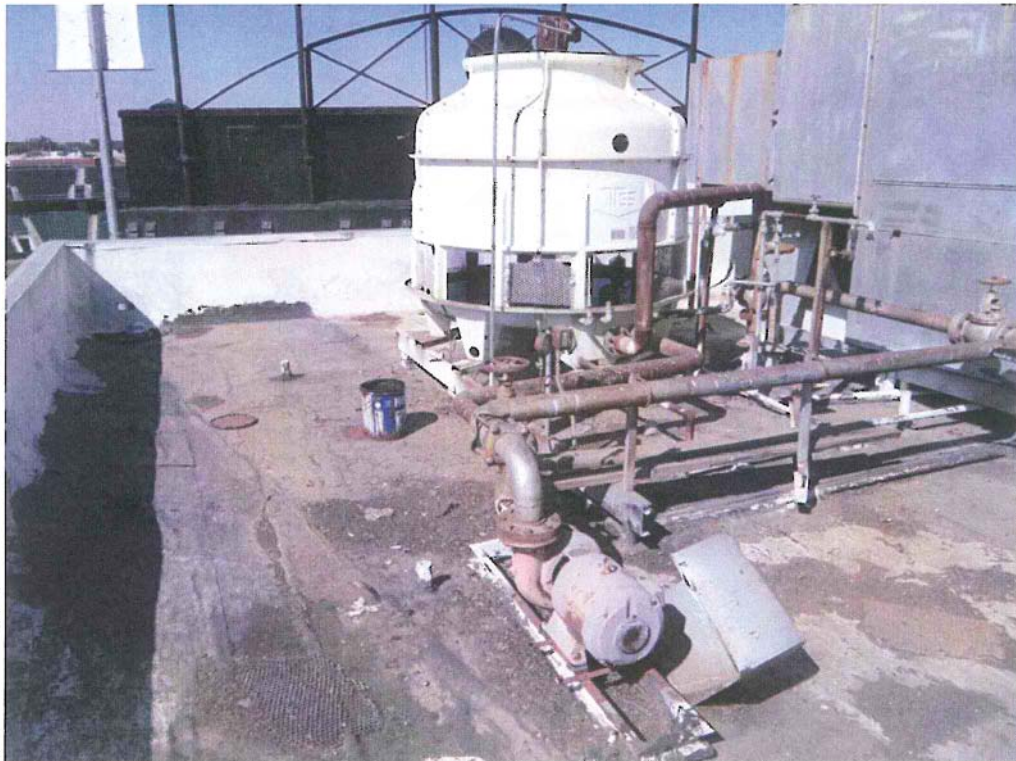
3. The current HVAC supports appear to be adequate.
4. Widespread repairs were observed in the field of the roofs.
5. Evidence of wide-spread leakage was observed at interior portions of the building.

Photograph Number 14  
Field Repairs at Mechanical Area

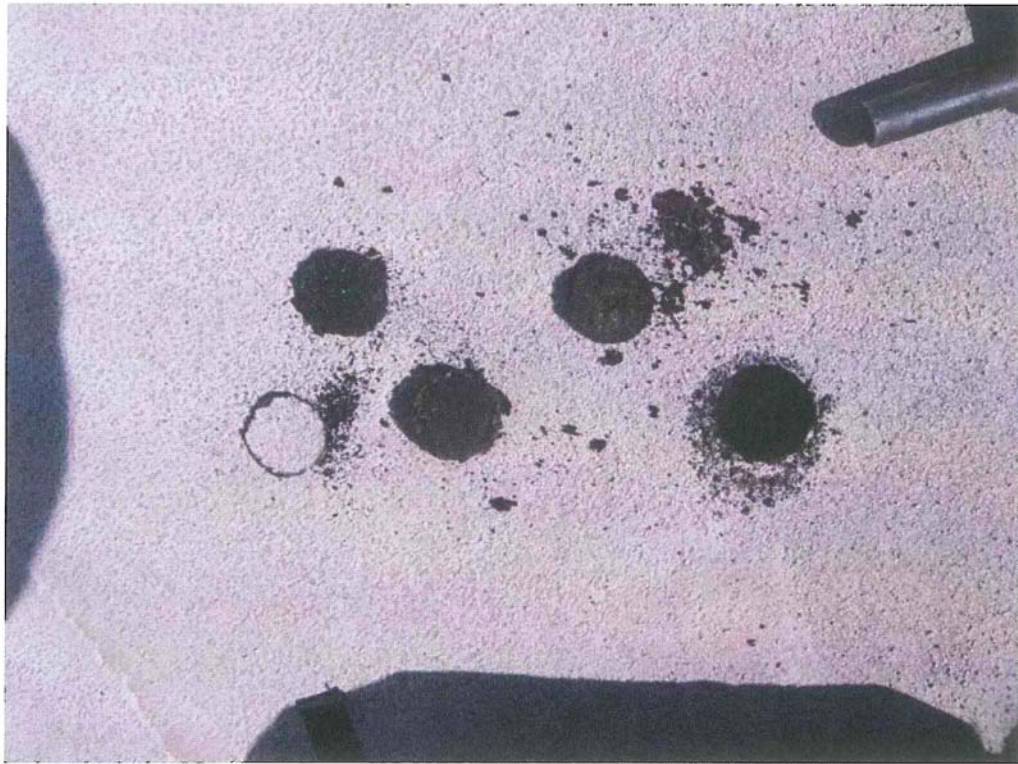
The structure includes a total of two (2) asphaltic built-up roofs with a layer of rigid insulation.

Photograph Number 15  
Roof Core Sample - 2 Roofs

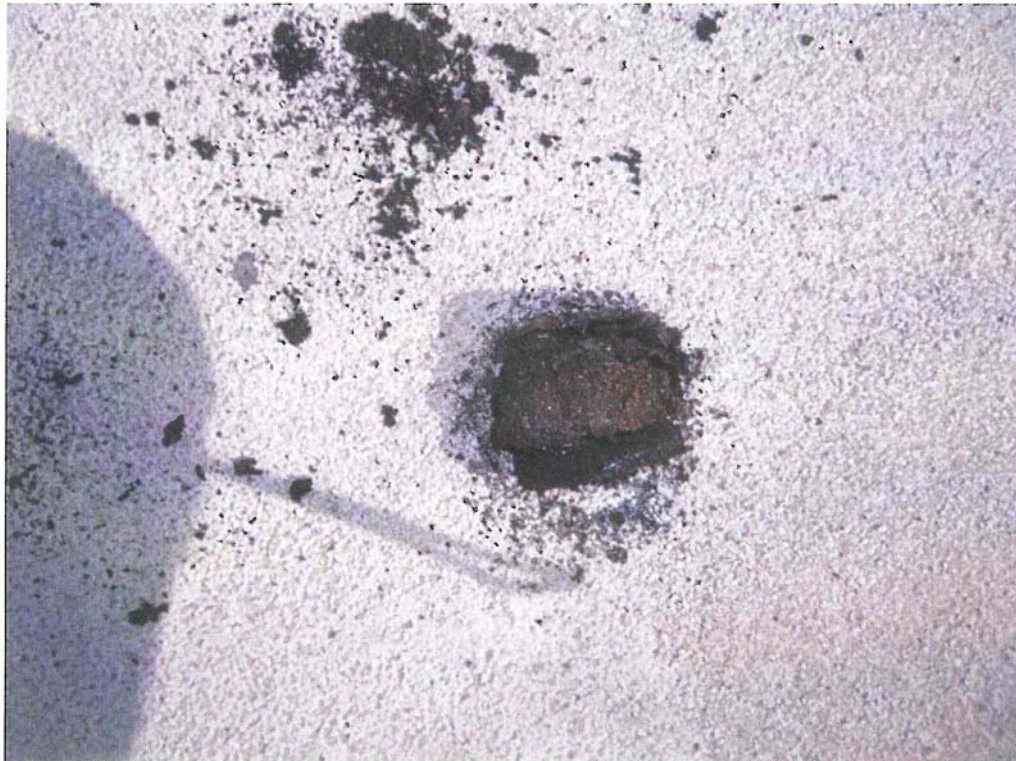
Photograph Number 16  
Close-Up of Roof Core
